# Fouling resistance test on Ceramic Coated Tubes via Dimethyl Ether degradation

**Sanjay Lodha, Global Business Director – Tubacoat S.L.**

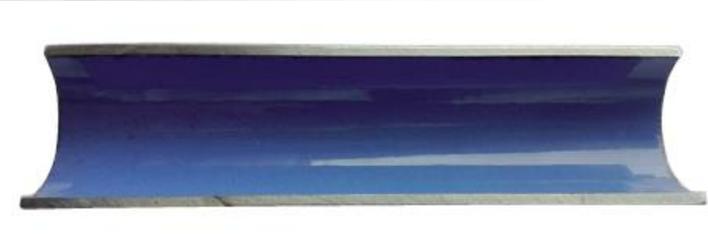
Ceramic coatings can be applied to different substrates such as Carbon Steel, Low Chromes, Austenitic Stainless Steels and Nickel Alloys on the Outside Diameter (external surface) or to the Internal Diameter (internal surface) of tubular products (tubes and fittings) ranging from  $\frac{3}{4}$ " to 10" OD for different applications.

External surface

Internal surface

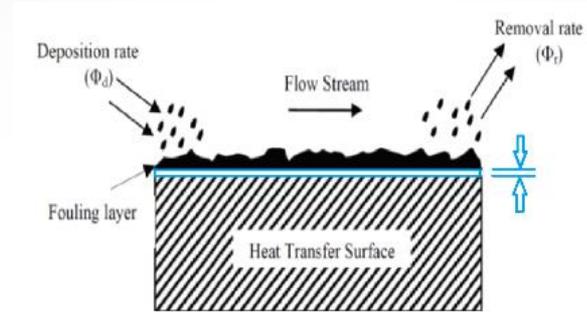
The ceramic glass-finished layer will protect the inner or outer surface of the tubes of any heat transfer equipment

- ↓ Deposition Rate will decrease due to its chemical inertness
- ↑ Removal Rate will increase due to its anti-adherence properties
- ↓ Heat Transfer loss will improve due to lower fouling layer
- ↑ Fluid Flow will maintain/increase the stream

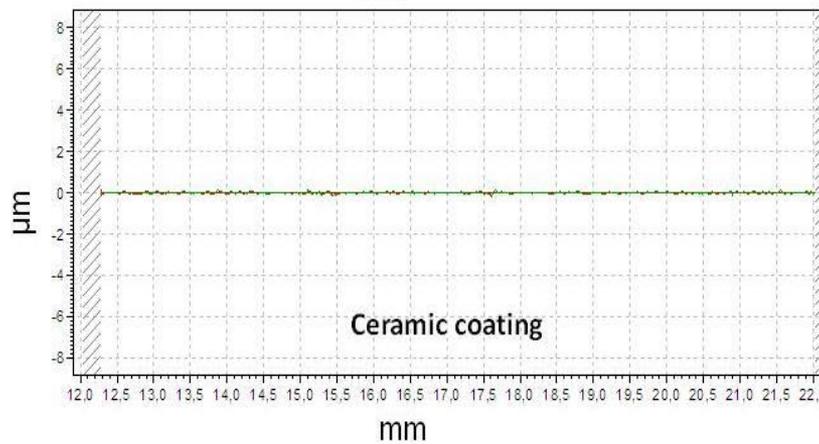
### Roughness

**$R_a < 0.04 \mu\text{m}$  and  $R_z \approx 0.3 \mu\text{m}$**

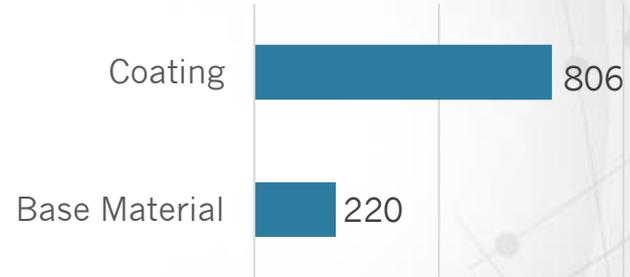
### Hardness [HV]

**4 times harder than base material**

According to ASTM C 1327-03

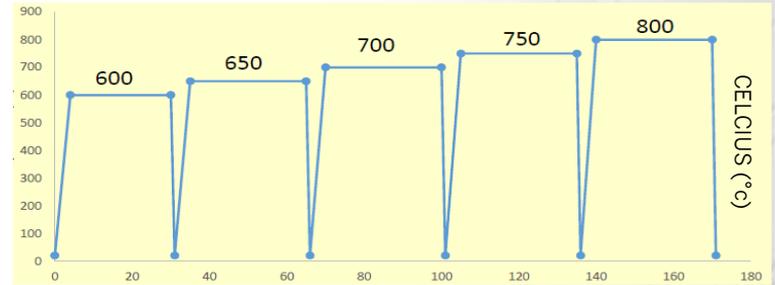
### Thermal cycling Resistance

Thermal cycling (30min) + Rapid water cooling (20°C)

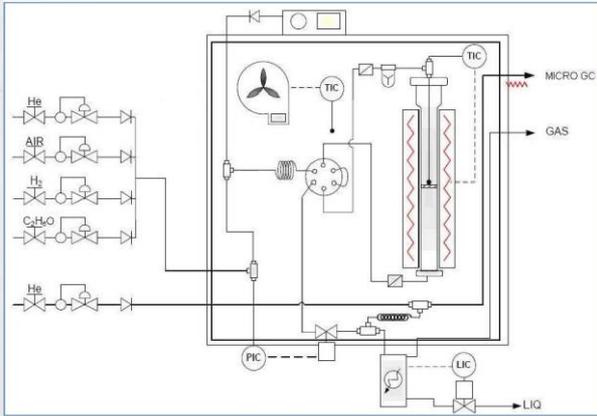
- The testing rig was equipped with a tube sample located in a heated chamber and connected on-line to a gas chromatograph

- 347H SS tubes
- 21mm ID
- 400mm length

- Feed Stream:
  - DME (Air Liquide, 99.99%) as reactive gas;
  - N<sub>2</sub> (Air Liquide, 99.99%) as inert gas, and;
  - Purified air (Carbueros M, 99.99%) as comburent.

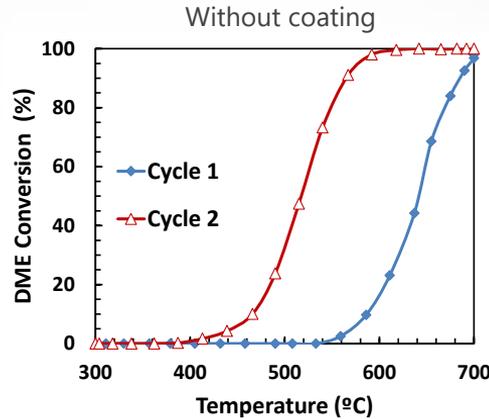
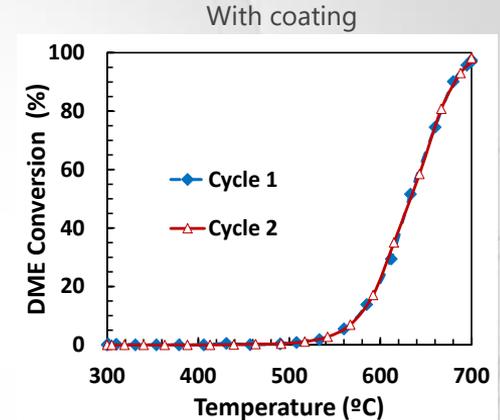
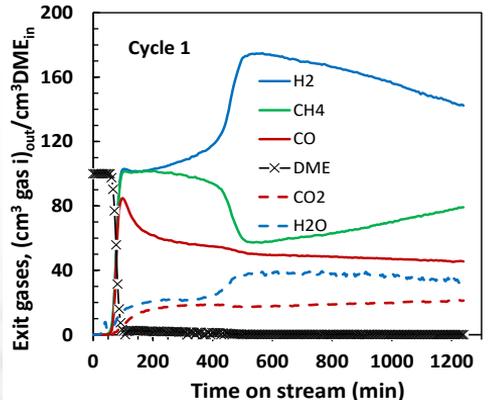
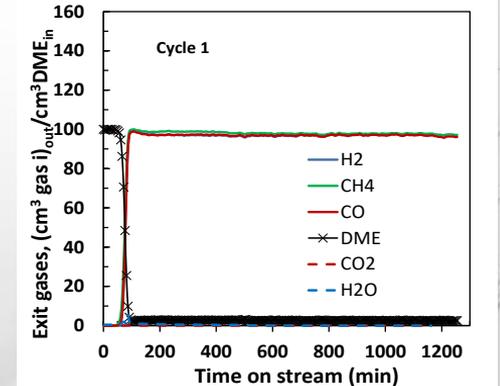
## DME Degradation step

- Temperature = 700°C
- Residence time = 60s
- Time on stream: 20 h

High H<sub>2</sub> + presence of (CO<sub>2</sub>+H<sub>2</sub>O)  
in the non coated tube

**high solid carbon formation  
on non coated tube**

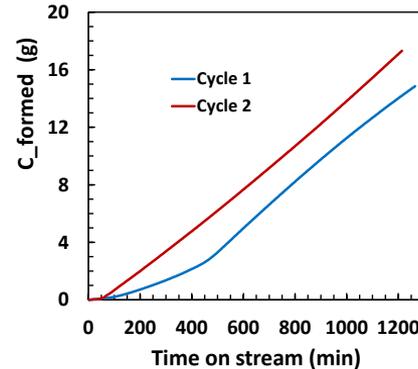
Without coating

Carbon deposited

Integration of (CO + CO<sub>2</sub>) curves

**high carbon deposition on non-coated tube**

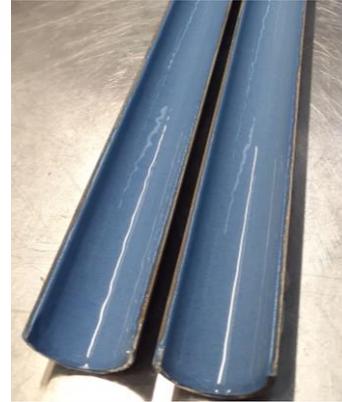
TUBACOAT anti-fouling  
inner coating

- Increased fouling resistance
- Increased heat transfer and reduced pressure drop
- Avoids frequent cleaning
- Avoids hotspots

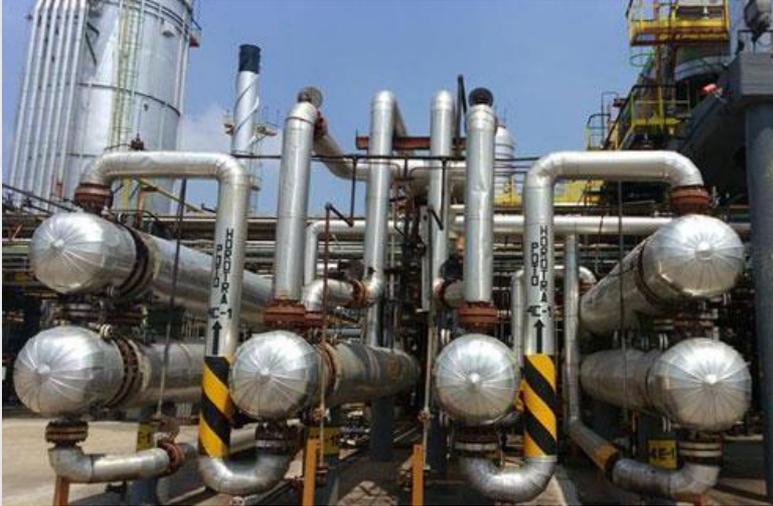
## Condenser corrosion

Corrosion in condensers is one of the most common problems in refineries and chemical plants, causing:

Condensers are critical equipment subject to corrosion in many applications such as Sulfur recovery units, CDU, Hydrotreating or chemical plants

Tubacoat can be applied on the **inner or outer surface of condenser tubes** to avoid corrosion caused by many different corrosive media such as nitric acid or sulfuric acid.

Corrosion in condensers many times starts under deposits. In these cases, Tubacoat **anti-fouling properties** further enhance corrosion resistance.

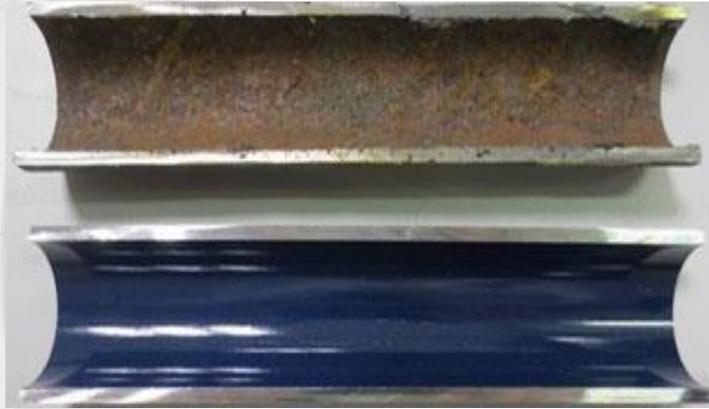
Condenser tube

Condenser tube with Tubacoat  
internal coating
